Short report on Rapid Hydrogeological observations of Springs and Lakes in parts of Sikkim State

Devdutt Upasani

Advanced Center for Water Resources Development and Management (ACWADAM), Pune

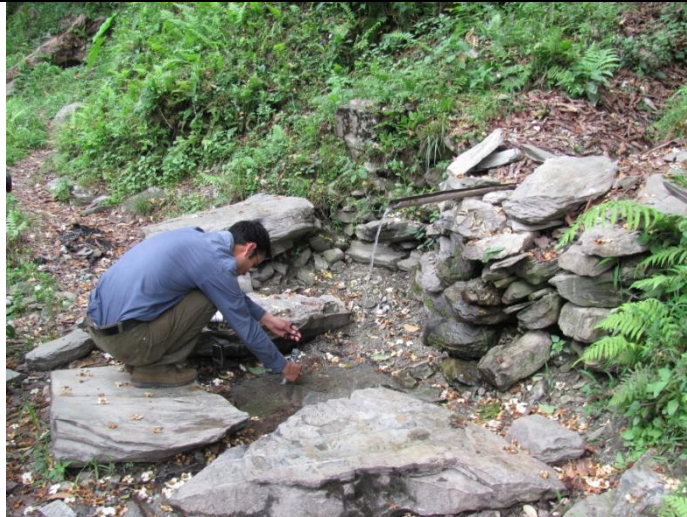
Sasbote Dhara: Mainly a *depression* spring as it is surrounded by sediments around it and the spring is formed at a change in the slope gradient of the ground. The discharge of water is about 2.5 lpm. The rock type below the sediments is augen gneiss. The discharge in the spring shows quick response to the rains, which indicates it to be a quick and local system and the water discharged from the spring has travelled a short distance in the ground before getting discharged.

Photo 1: Tracer being used for water quality testing at Sasbote dhara

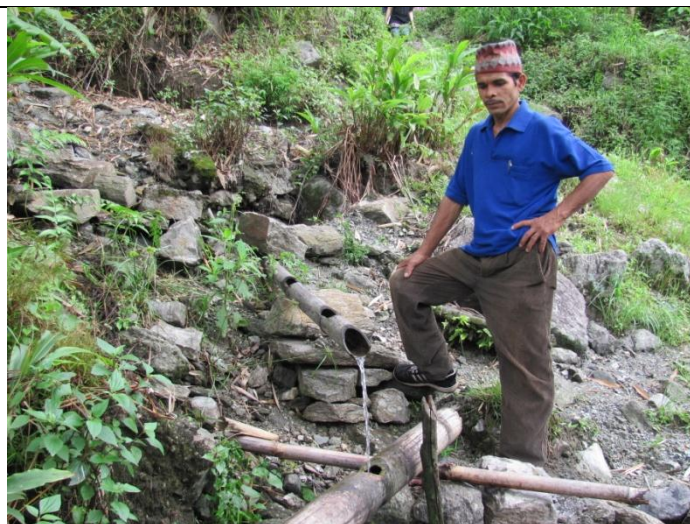
Photo 2: Manahang dhara located along a fracture zone.

Dal Dhara and Manahang Dhara: These two springs are also *fracture* springs located along fractures trending in N-S direction. There are many more springs in this area, all located in zones trending

along this N-S direction. These are all fracture springs located along parallel set of fractures trending in a direction of 0°-180°. The water quality measurements indicate water to be travelling from a considerable distance along these fractures but at fairly high transmission rates.

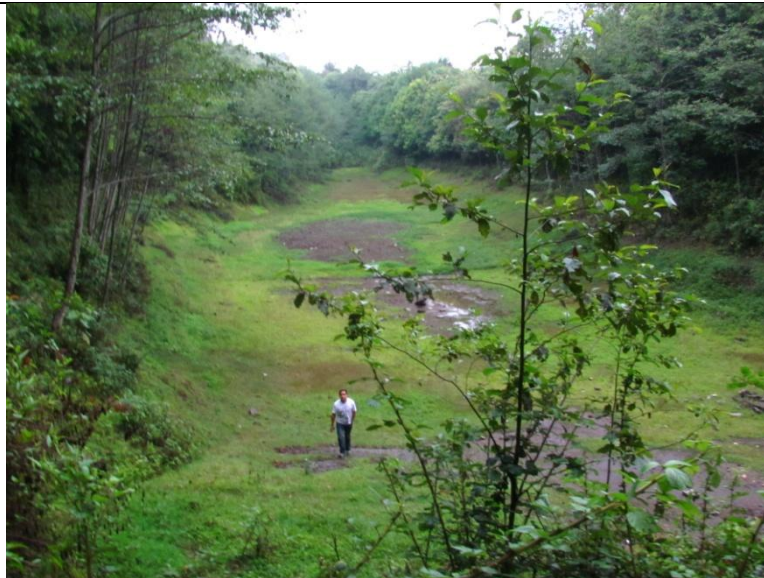
Poison Lake: The dried up lake in Kaluk area was studied to ascertain the contribution of groundwater to the lake. It was observed that the reduced inflows in the lake have led to a drying up of the lake. The masonry work done in the lake near the outlet has led to reduced groundwater flow to the lake as it has obstructed the main eastward flow of groundwater to the lake. Also, reduced discharges from a spring located towards the upstream part of the lake have contributed to the drying up of the lake. Recharge activities in the western direction of the lake on the escarpment slope and the top flat portion of the hill will prove significant in increasing spring discharge and

Photo 3: Dried bed of poison lake

baseflows to the lake. Puncturing of the masonry portion can also be considered as a possible intervention for the lake.
